Project Update: Creek Photos, Before & After

Stevens Creek has been restored within Blackberry Farm as part of the Stevens Creek Corridor Phase 1 project. This update contains photographs of the creek, before the work and after.

Stevens Creek Corridor Creek Restoration Project

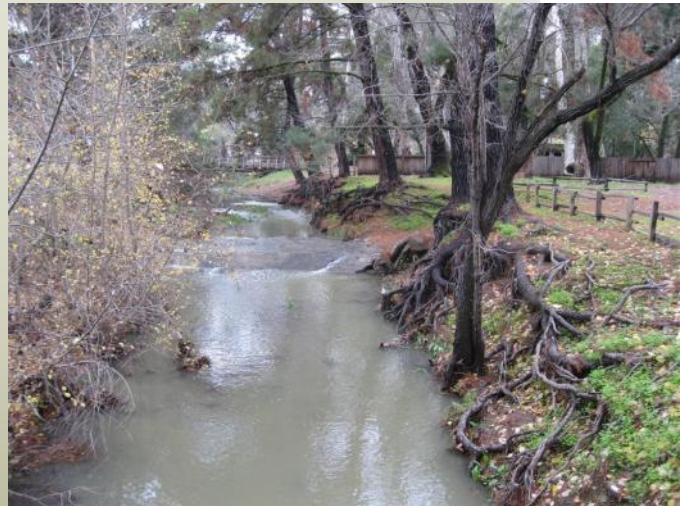
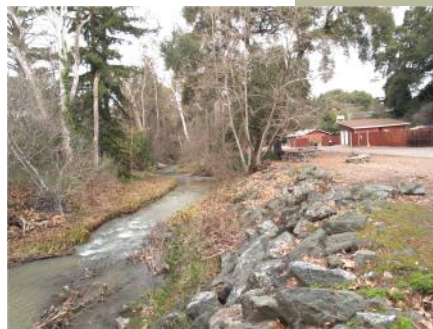
Stevens Creek: Before

*W*ithin Blackberry Farm the creek channel had been narrowed. Creek flows scoured the banks & tree roots. Understory vegetation was lacking & habitat value was limited.

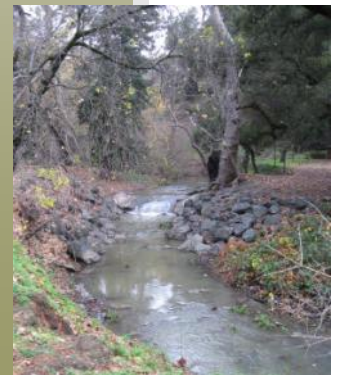
*I*n numerous locations, "riprap" rocks were needed on creek banks to protect against scour forces. Serious barriers for wildlife existed within the channel itself.

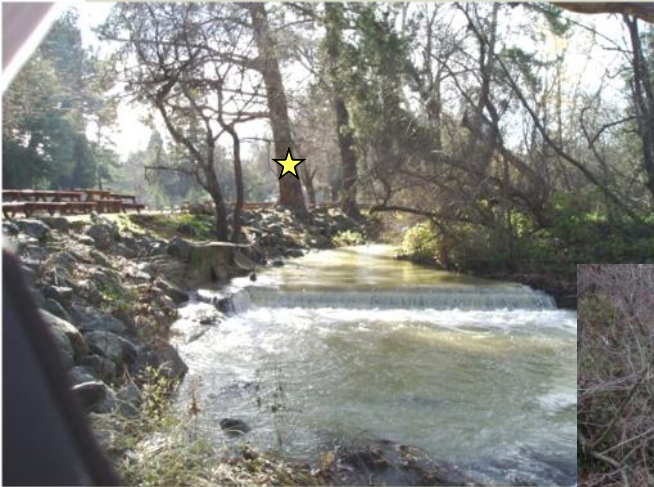
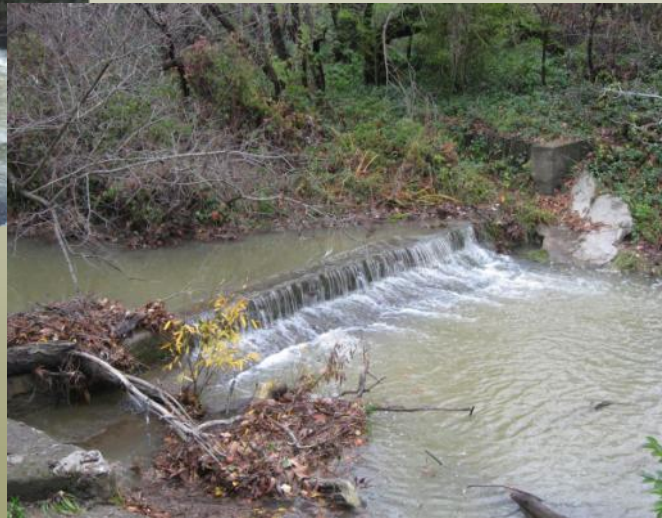
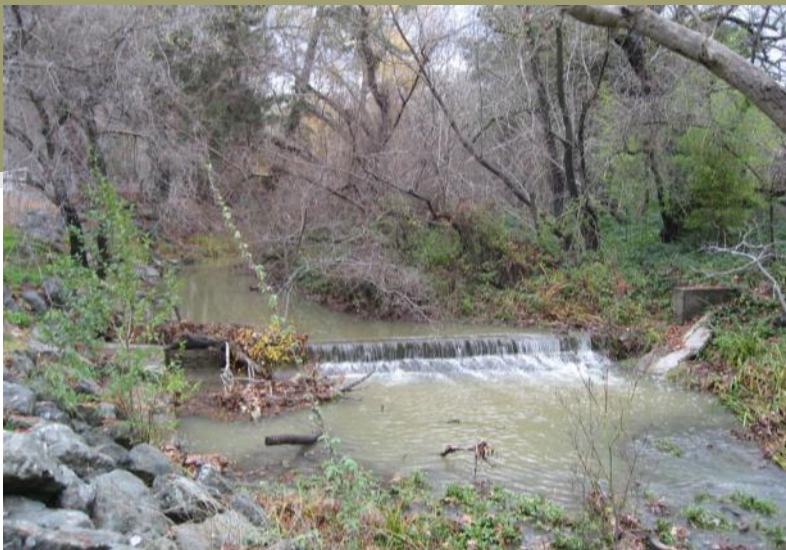
Diversion Dam Site: Before

The dam structure within Blackberry Farm created a major hurdle for fish passage.

Riprap (rock armoring) placed on the east bank at the dam site further degraded the habitat.

This dam was one of the worst barriers for year-round movement of young steelhead in the entire length of Stevens Creek.

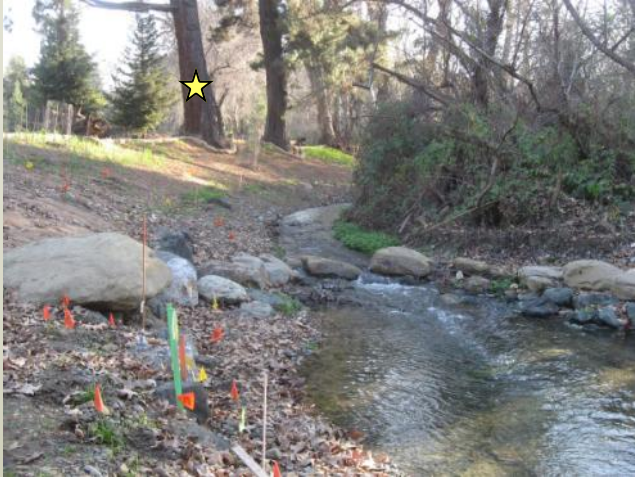
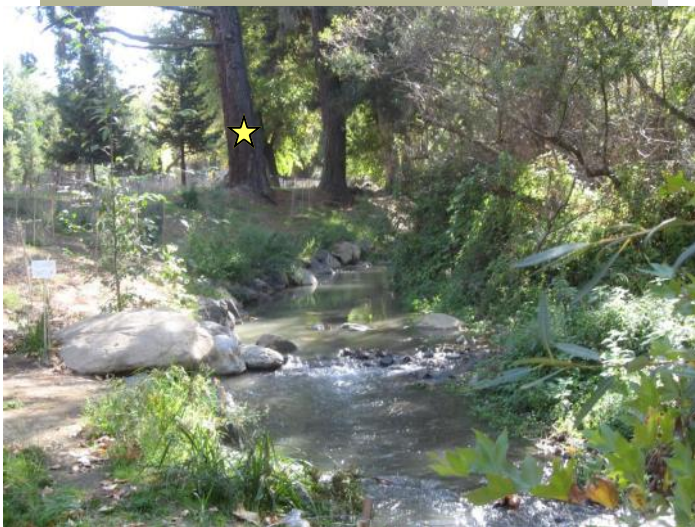
Looking Upstream

A new pool was created below the boulder cross vane. The cross vane will stabilize the channel bed at the proper elevation and maintain the improved fish passage conditions.

Photos above & below are views upstream, Oct. 2008 & Sept. 2009.

The dam structure was removed, as was the riprap. The banks were laid back to a gentler slope that will be stable without armoring. The channel was sculpted as well and a boulder "cross vane" was constructed at the former site of the dam. Photos below are views downstream, Oct. 2008 & Sept. 2009. A star marks the same tree in each view.

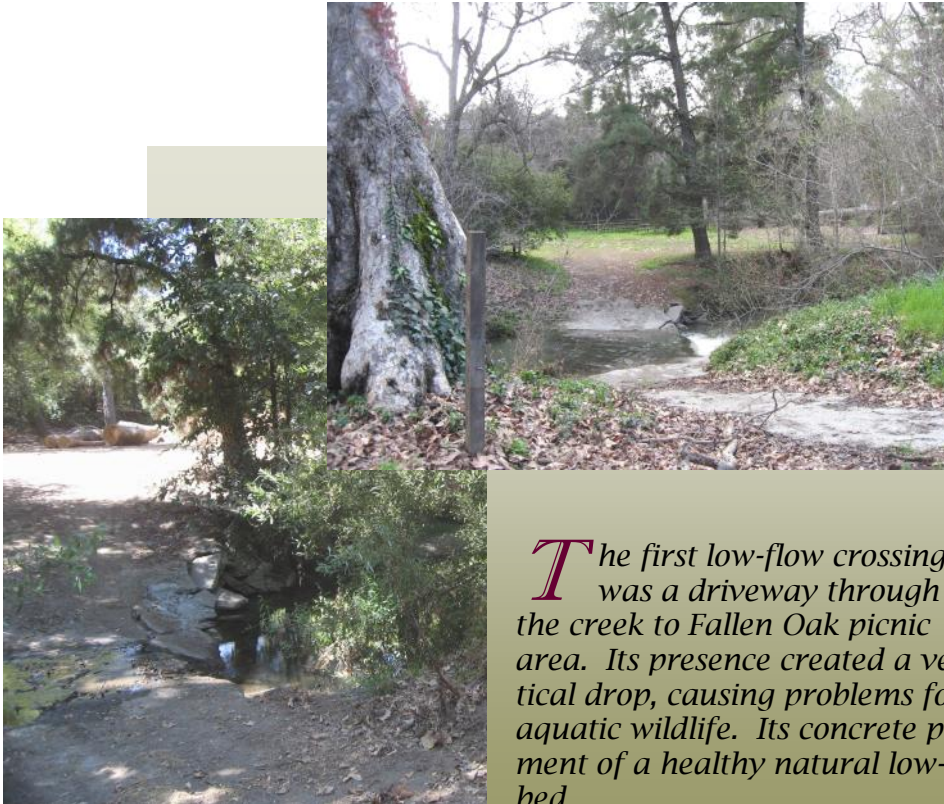
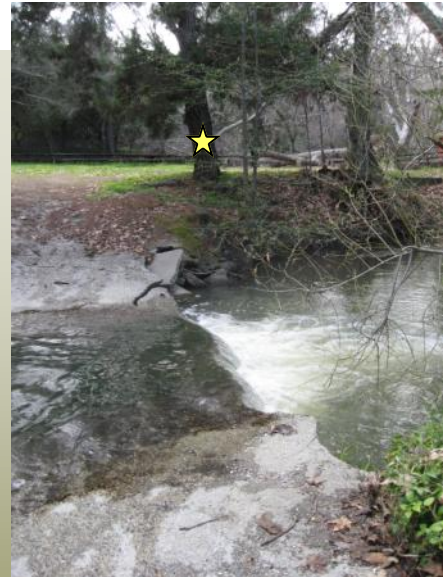
Low Flow Crossing #1: Before and After

The first low-flow crossing was a driveway through the creek to Fallen Oak picnic area. Its presence created a vertical drop, causing problems for aquatic wildlife. Its concrete paving prevented establishment of a healthy natural low-flow channel in the creek bed.

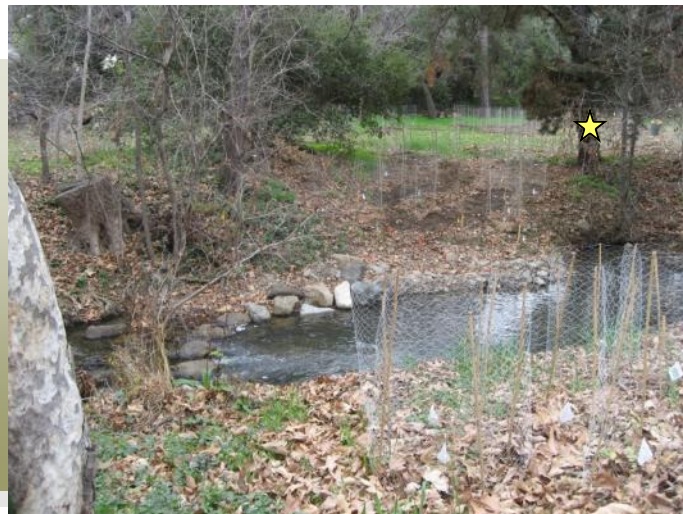
The creek restoration, photo right, removed the low flow structure and resculpted the channel, preserving the nearby trees and vegetation.

The star marks an adjacent tree as a landmark in the 'Before' and 'After' shots.

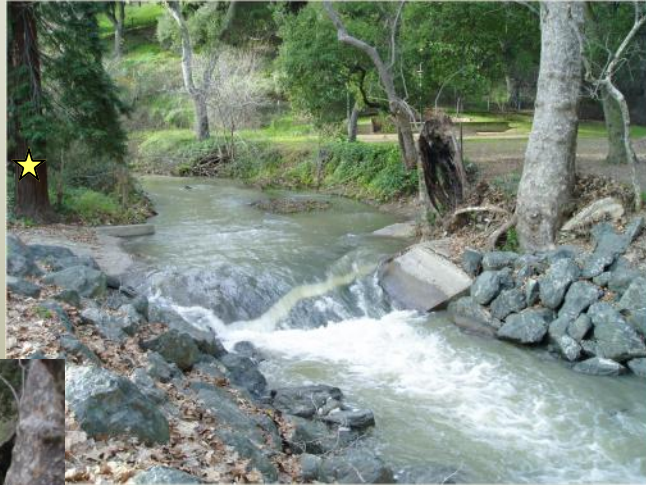
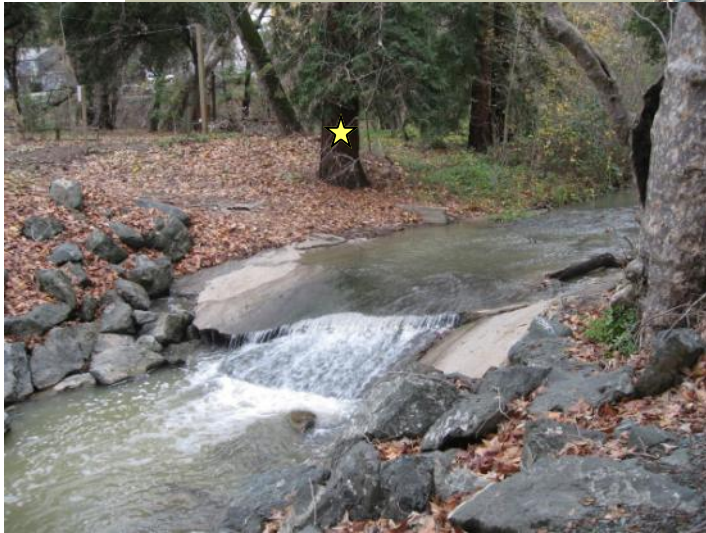
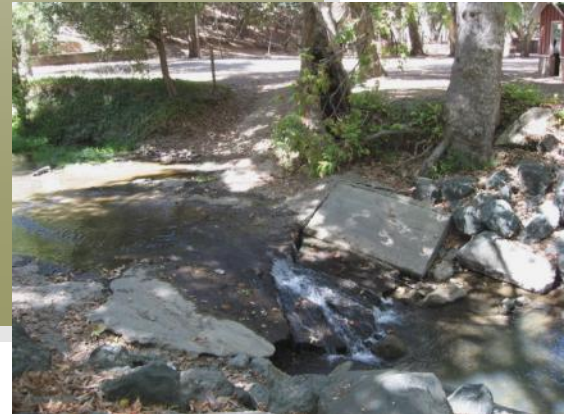
Low Flow Crossing #2: Before & After

The second low-flow crossing created a serious barrier to fish passage, with a channel drop of more than 4 feet. Rip-rap armoring on both sides of the crossing precluded vegetation.

Views of the low-flow crossing 'before' are left, right & above.

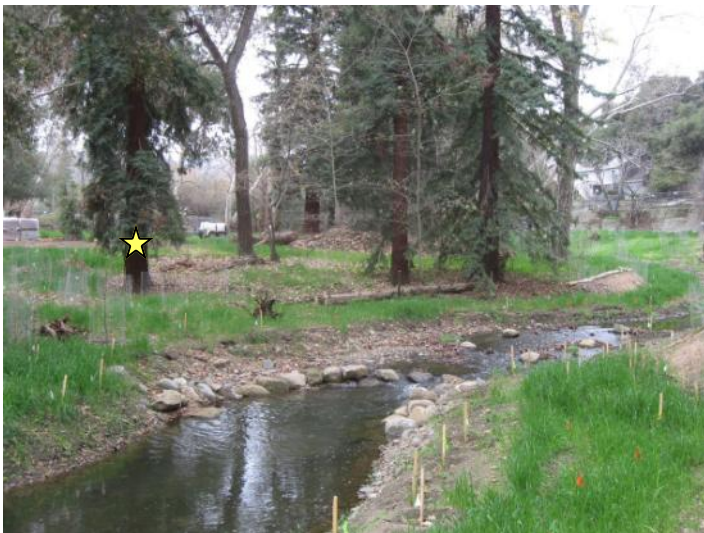
The creek restoration removed the low flow structure and riprap. The redwood tree marked with a star in the upper photos is the same tree marked in this post-construction photo left. A boulder cross vane helps stabilize the channel bed and create a pool-glide-riffle sequence.

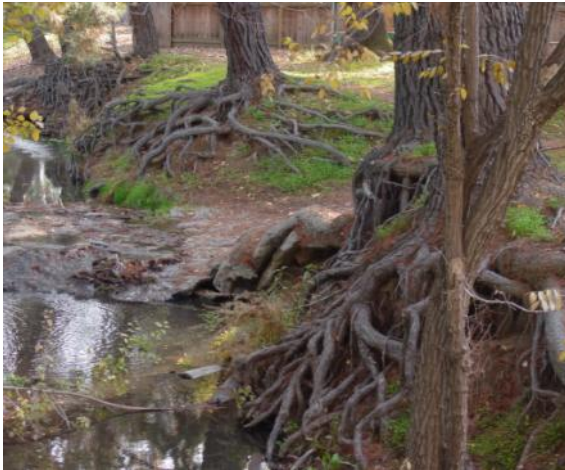
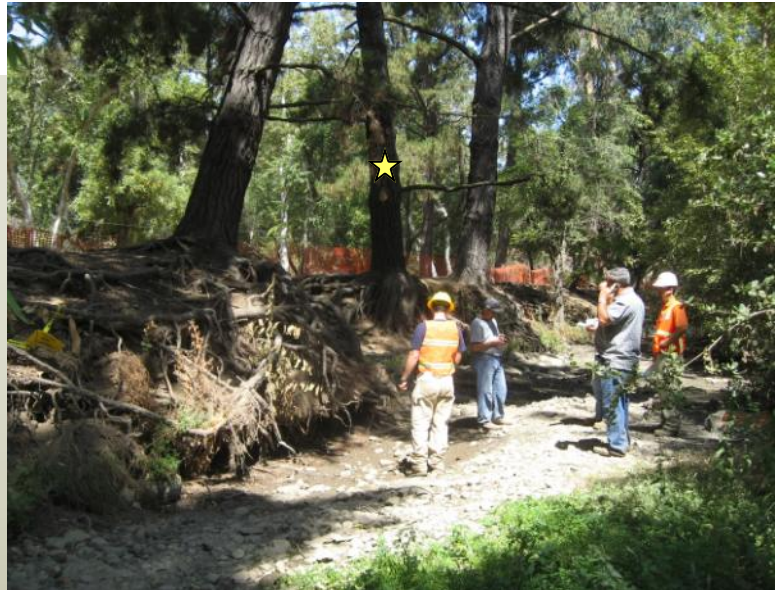
Scoured Tree Roots: Before & After

Creek channel flows had scoured the root systems of Monterey pine trees along the creek banks.

The design team and contractor reviewed the scoured areas before beginning to construct log crib walls to protect roots.

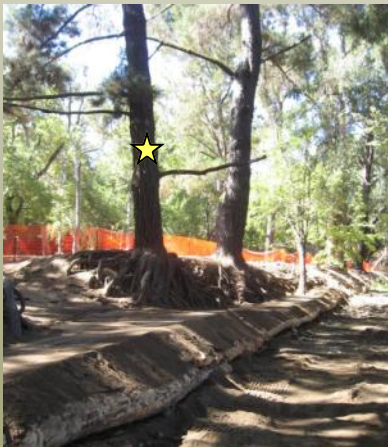
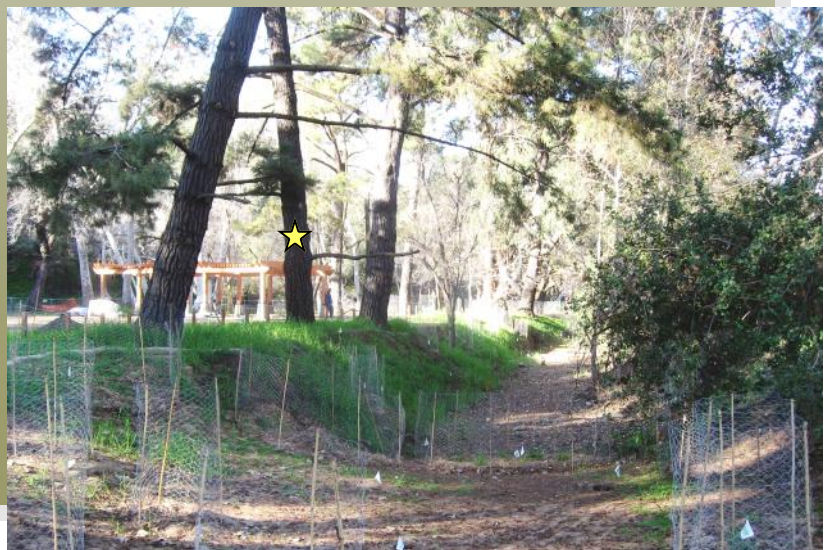
The photo below shows the same 3 trees in the photo above, after installation of the crib walls & plantings. This portion of the former channel is now a "backwater" & provides refuge for fish during high-flow winter storms.

Log walls (above) were backfilled in lifts with selected soil material placed carefully around roots. A new slope was created providing space for healthy root systems to reestablish.

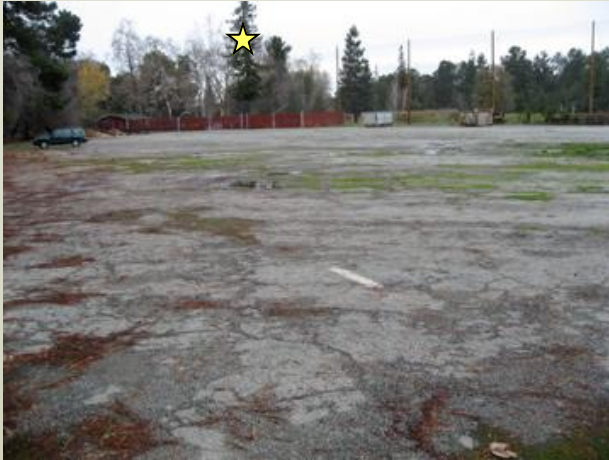
Lower Parking Area Before: New Creek Channel After

The lower portion of the former parking lot shown in photo left was removed. It became part of the new creek channel, allowing creation of a wider, stable and healthy channel configuration.

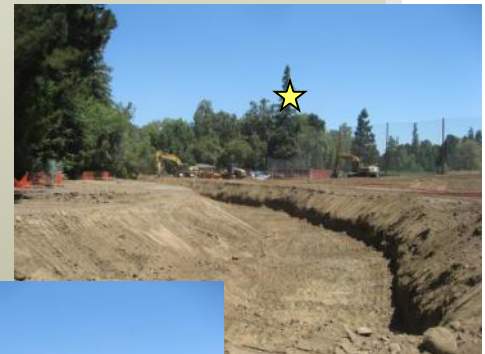
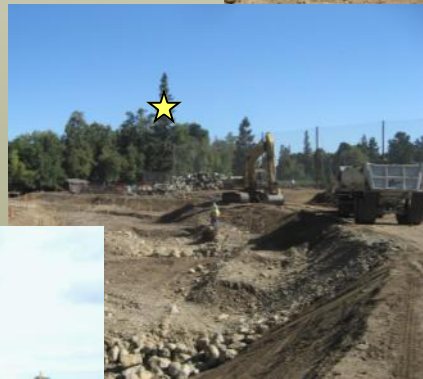
During construction, the new channel was excavated. Cobbles and gravels were used to create the new creek bed.

A star marks the same distant tree in each photo.

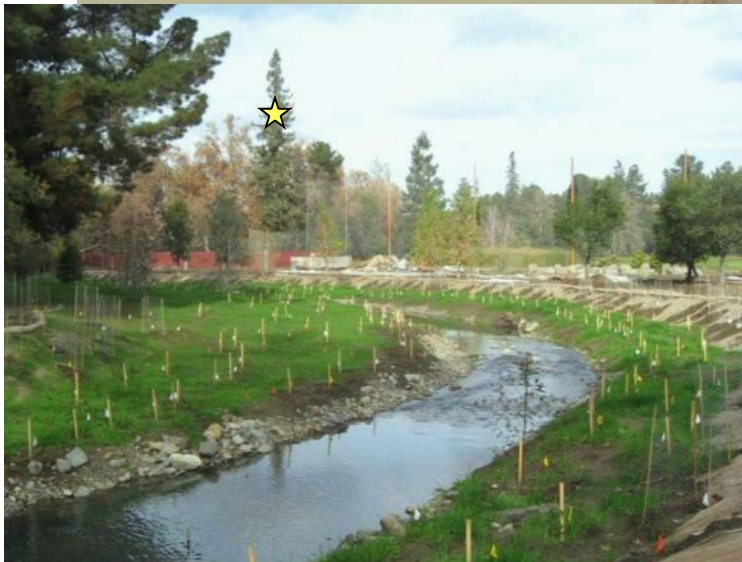
The brand new creek, shown photo left Dec. 2008, was created where parking had existed. The new channel allows for desirable in-stream floodplain "benches" and supports greater habitat complexity. The channel slope is gradual and there are no longer barriers to fish migration.

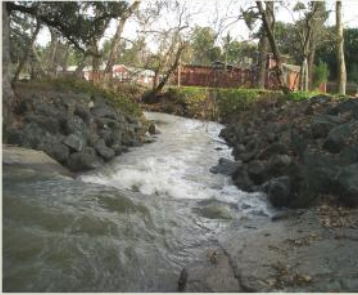
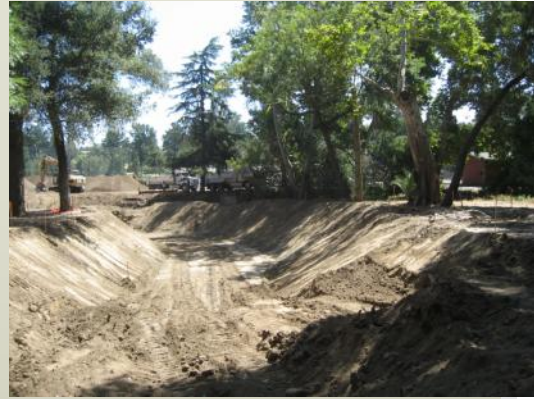
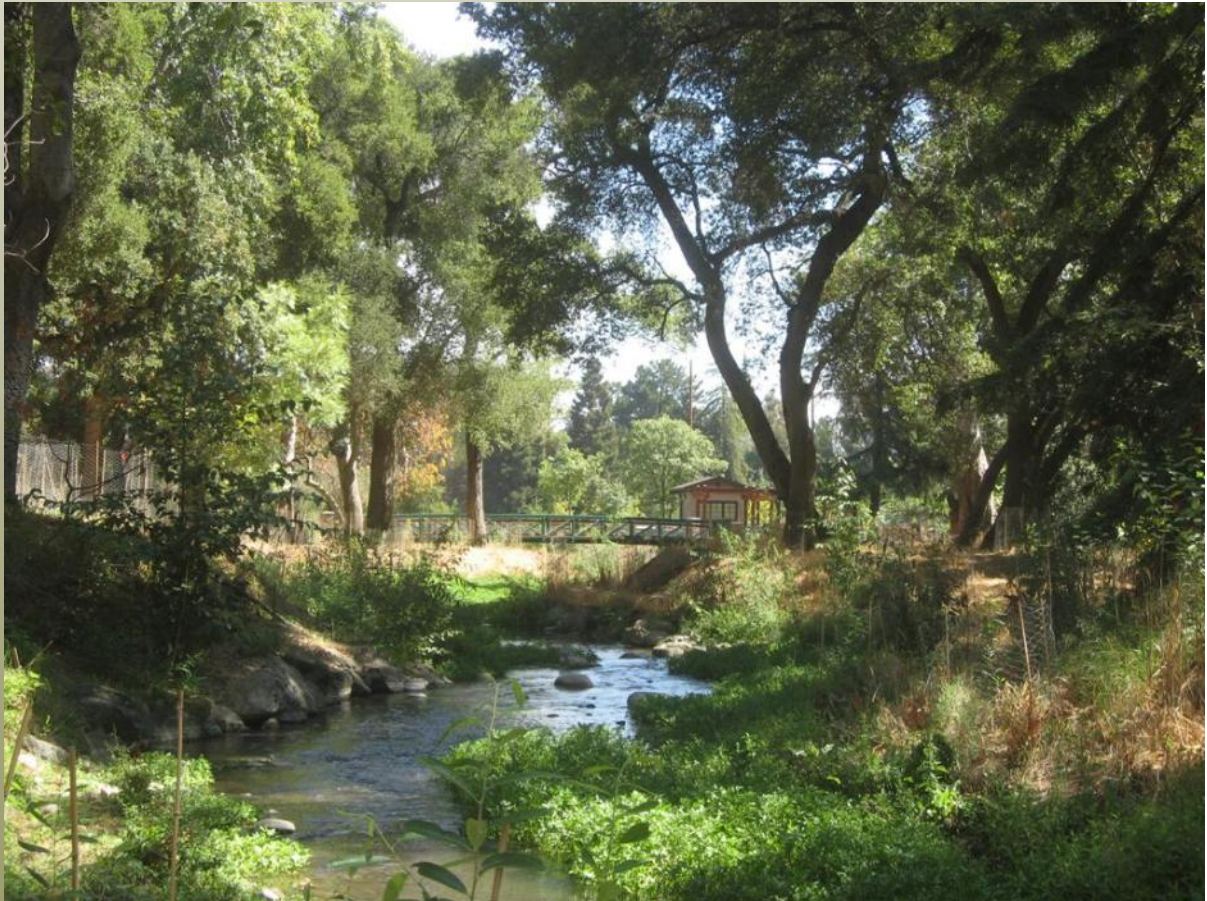
New Creek Channel, One Year Later

Just downstream of Horseshoe Bend, the old creek channel 'before', left, and the new relocated channel 'during', right. One

year after construction, below. This is a new stretch of creek that did not exist before.

*N*ative plantings are establishing well, as are volunteer pioneer species. Steelhead are back in the creek and native plant diversity is rising.
